# Manhole Inspection Summary

Manhole # S09AA2023MH

Insp Date: **7/17/06 9:07 AM**

**Location** Address: **2705 ROCKWOOD AVE**

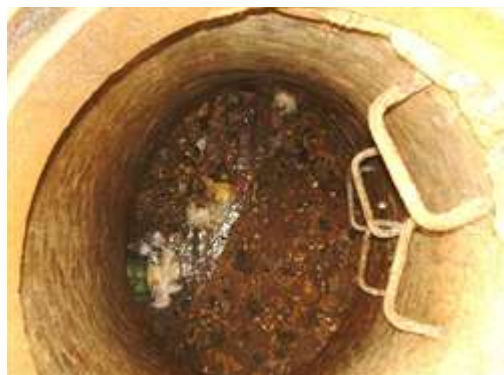
Top View

Channel debris.

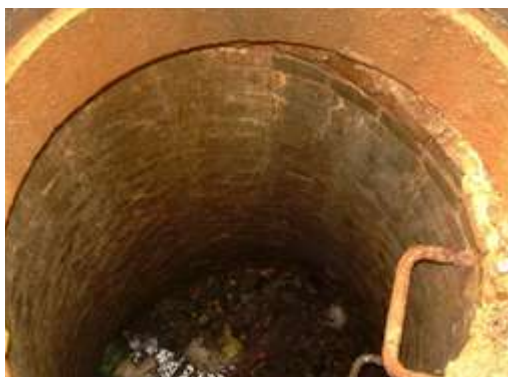
Defect

Frame leaks. Frame offset. Adjustment deterioration, loose brick, and infiltration. Corbel infiltration - other side.

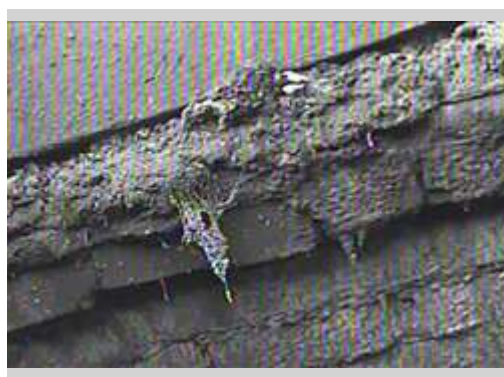
Defect

Frame leaks. Adjustment deterioration, root intrusion and infiltration. Corbel infiltration.

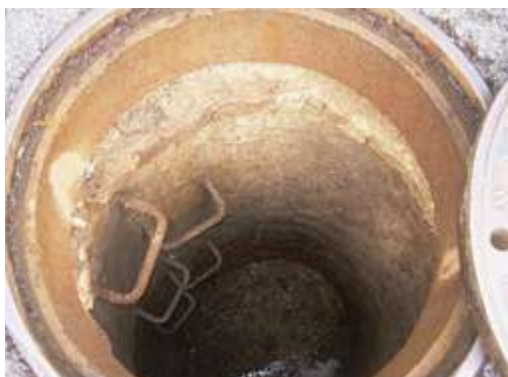
Defect

Frame leaks. Frame offset. Adjustment deterioration, loose brick, and infiltration. Corbel infiltration.

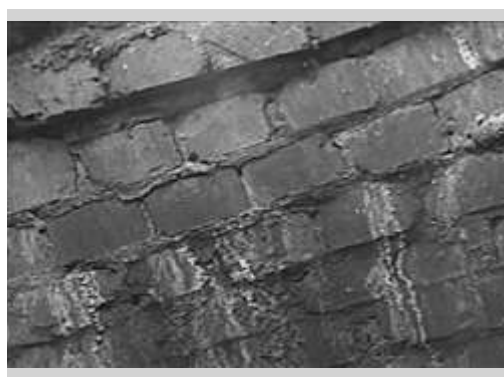
Defect

Corbel infiltration.

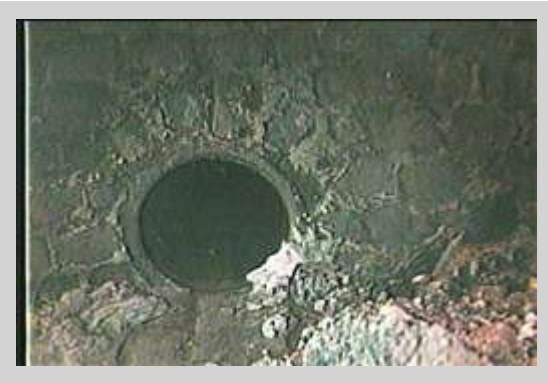
### 8 in. Circular Gravity Sewer Pipe Out @ 12 O'Clock

Barrel deterioration and infiltration.

Infiltration: **Evidence** Pipe Seal Cond: **Cracked**

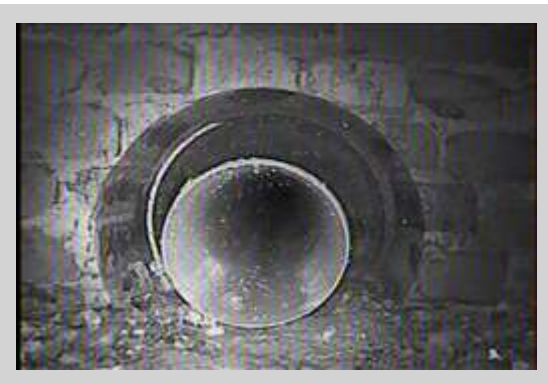
### 6 in. Circular Gravity Sewer Pipe In @ 9 O'Clock

Comments **The I9 doesn't have a pipe seal. There is a pipe inside of a pipe.**

Infiltration: **Evidence** Pipe Seal Cond: **Unknown**
